101 Year Old Church Put Back Together After Hurricane Harvey Clegg Services, Victoria, Texas - "Most Unusual Move" 2017

101 Year Old Church Put Back Together After Hurricane Harvey

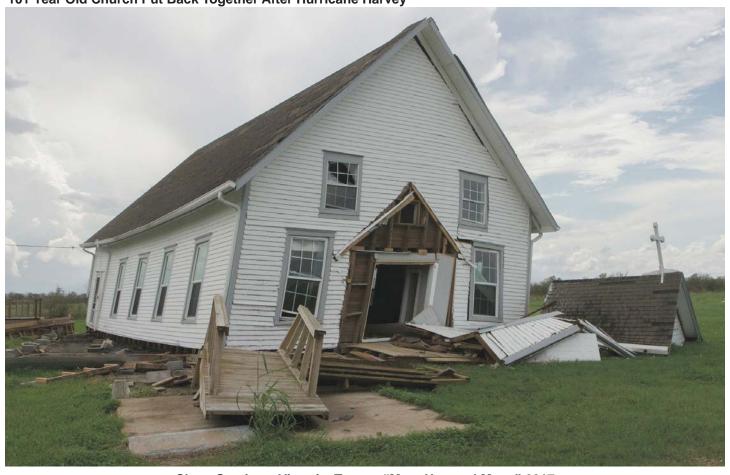
Clegg Services, Victoria, Texas - "Most Unusual Move" 2017
101 year old church gets blown about 15 feet off its foundation,
making the church lean at a 30-degree angle during Hurricane Harvey

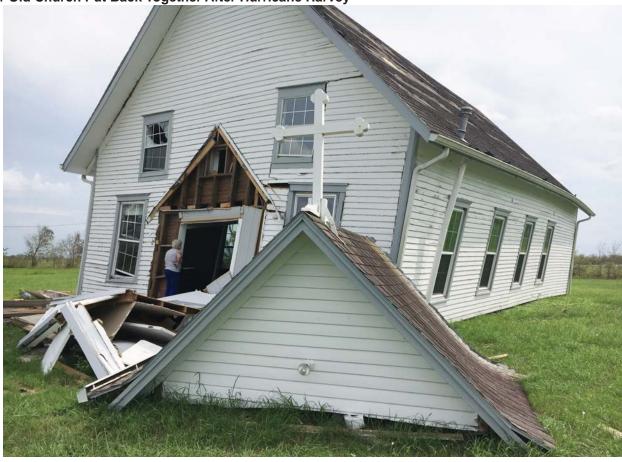
Clegg Services, Victoria, Texas - "Most Unusual Move" 2017
101 year old church gets blown about 15 feet off its foundation,
making the church lean at a 30-degree angle during Hurricane Harvey

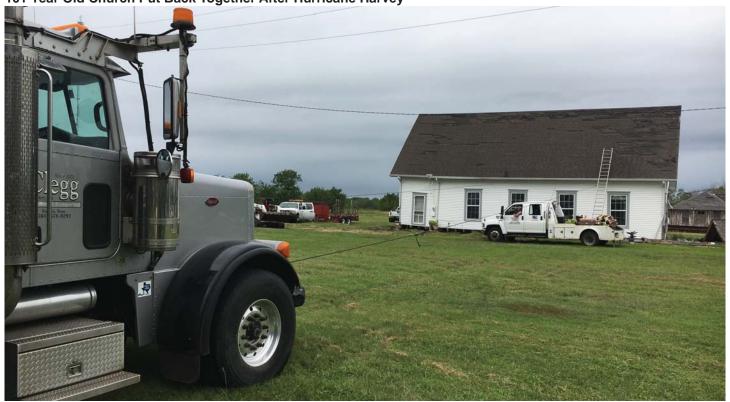
Clegg Services' crew pulled the church with cables attached to a truck to straighten it out as much as possible and wrapped a chain around the structure to secure it together.

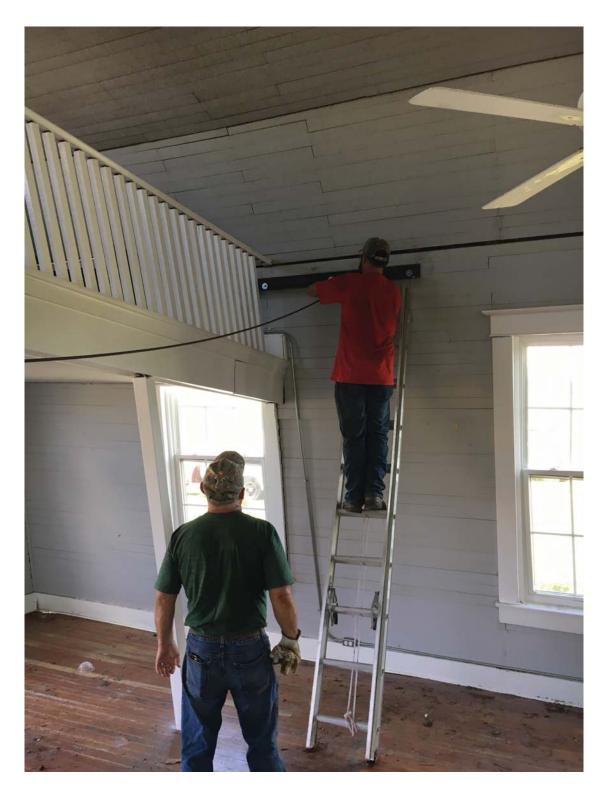
Clegg Services' crew pulled the church with cables attached to a truck to straighten it out as much as possible and wrapped a chain around the structure to secure it together.

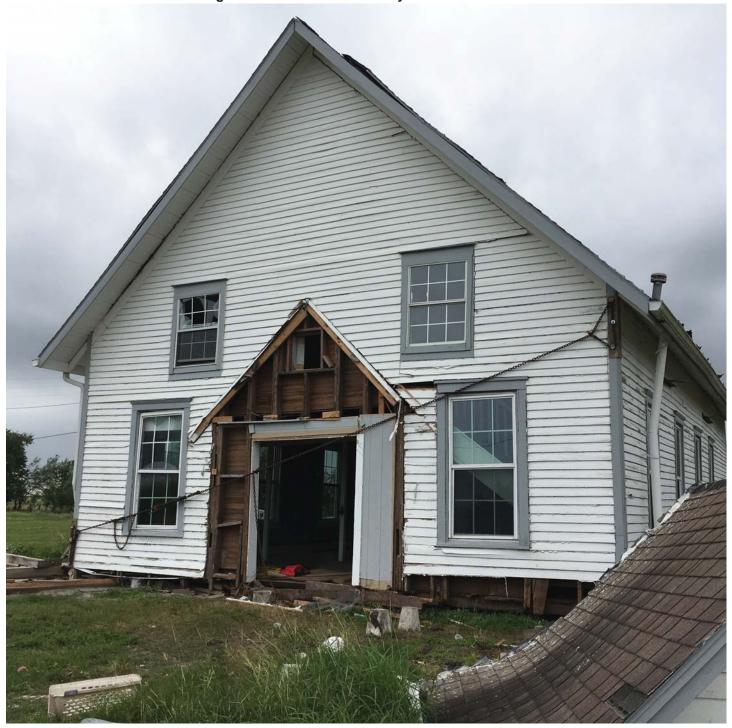
Clegg Services' crew pulled the church with cables attached to a truck to straighten it out as much as possible and wrapped a chain around the structure to secure it together.

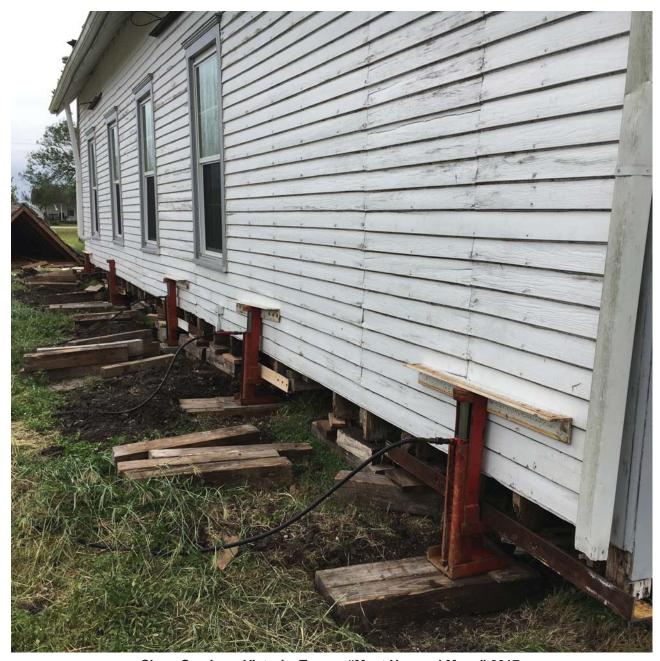
Crew lifts church up 4 ft. and does structural repairs, preparing for move. The floors and walls are reinforced.

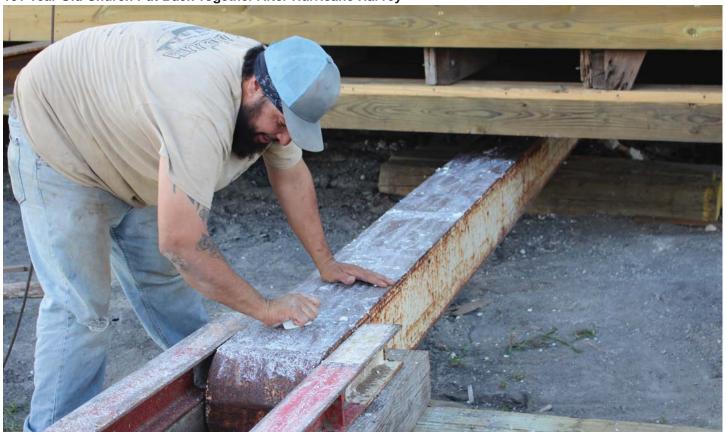
Crews put steal beams under the structure with Ivory soap between them so the church would slide back into position.

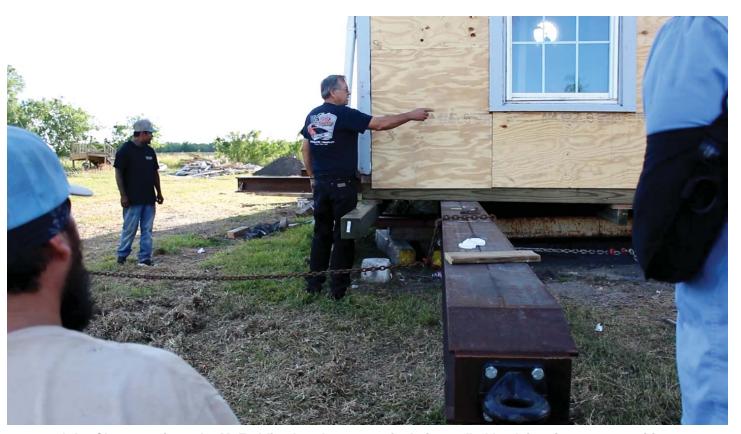
John Clegg monitors the McFaddin church move as its being pulled back into its proper position.

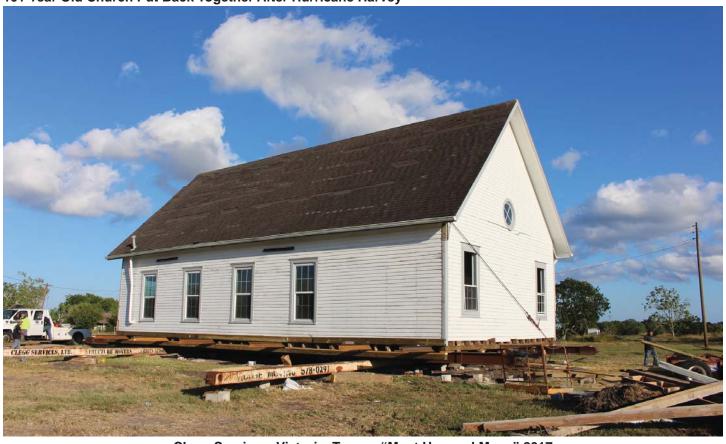
Clegg Services, Victoria, Texas - "Most Unusual Move" 2017 McFaddin church In it's final position.

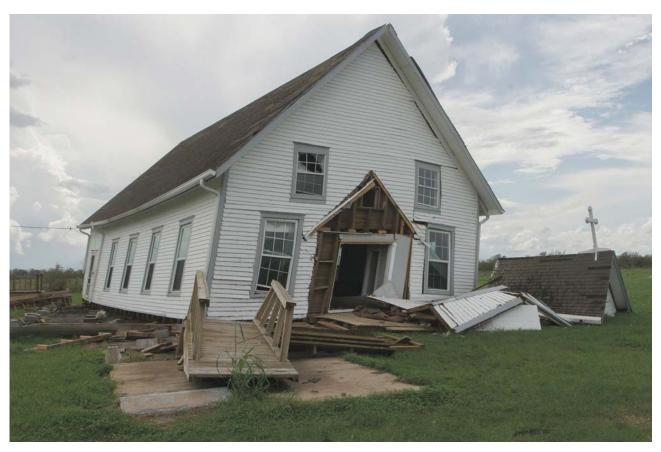
There's still a lot of cleanup to be done in the community, including fixing the old church, which was moved off its foundation by about 25 feet. The entryway steeple fell off the front.

The Infant Jesus of Prague Catholic Church, recently restored, lies in a wrecked state in McFaddin after Hurricane Harvey pounded the Crossroads.

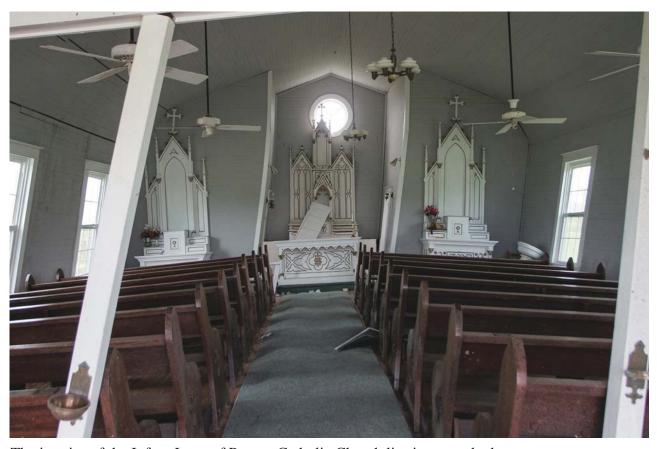
The interior of the Infant Jesus of Prague Catholic Church lies in a wrecked state.

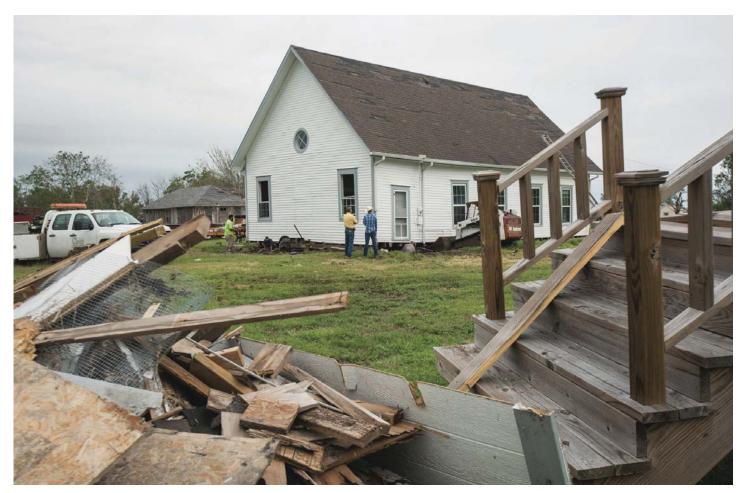
Clegg Services owner John Clegg, center, speaks with Mitchell Morrissey, right, while crews work to level the Infant Jesus of Prague Catholic Church in McFaddin.

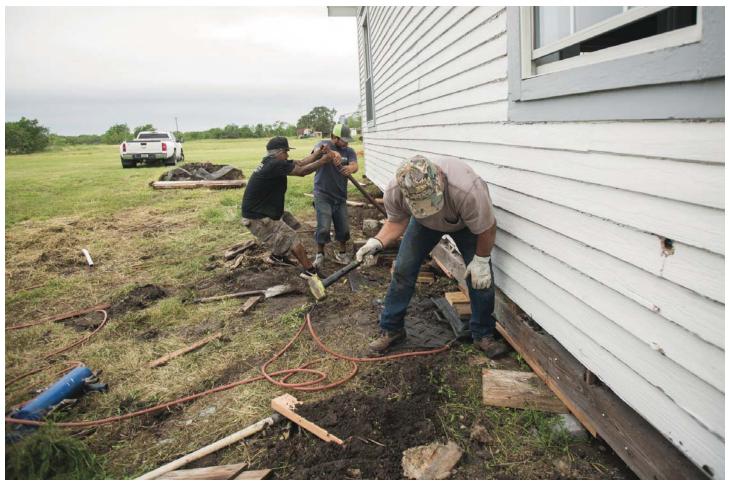
Mitchell Morrissey, 27, stands on the slumped floor of the Infant Jesus of Prague Catholic Church in McFaddin and looks at a cable wire strung through the walls. The cable is attached to a truck that helped level the church.

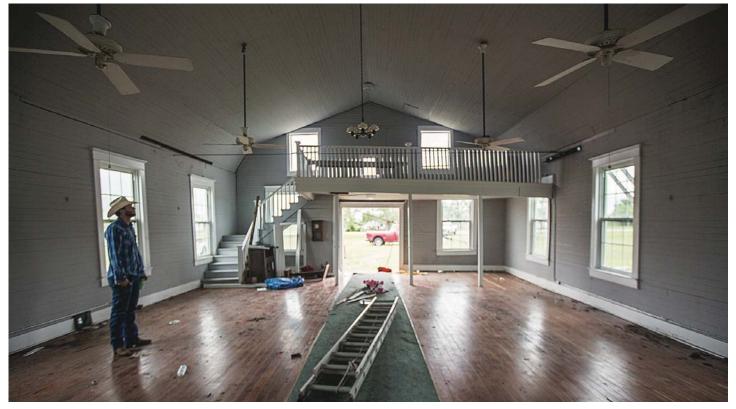
Mitchell Morrissey, 27, stands on the slumped floor of the Infant Jesus of Prague Catholic Church in McFaddin and looks at a cable wire strung through the walls. The cable is attached to a truck that helped level the church.

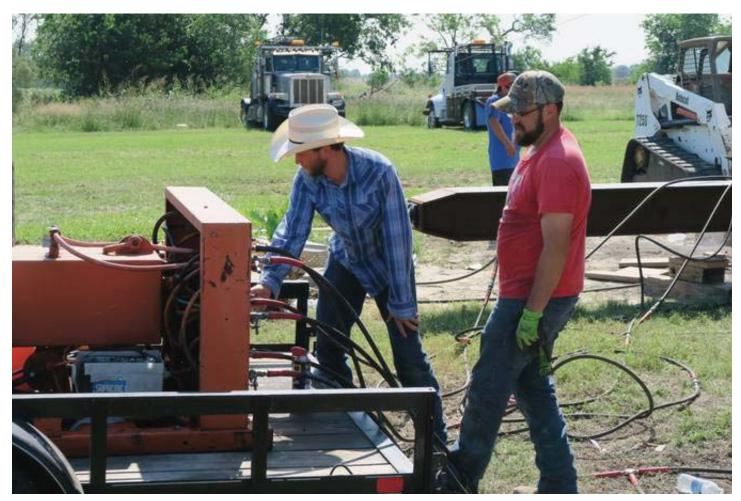
Mitchell Morrissey, of the McFaddin family, operates a pneumatic pressure lift to raise the Infant Jesus of Prague Catholic Church at the McFaddin ranch a few inches so steel beams can be soaped down with crumbled Ivory soap.

Mitchell Morrissey, of the McFaddin family, operates a pneumatic pressure lift to raise the Infant Jesus of Prague Catholic Church at the McFaddin ranch. Contributed by Gary Dunnam for The Victoria Advocate

Once the soap has been spread around, the shorter beams will be lowered back into place and the building will be pulled back onto its original foundation.

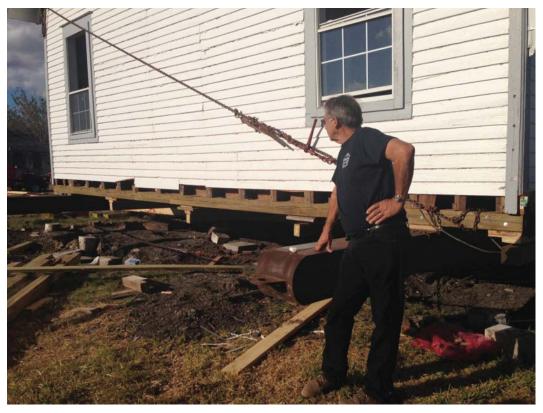
John Clegg, owner of Clegg Services, watches the McFaddin church move as its being pulled back onto its foundation.

Crews with Clegg Services and McMillan Building Movers pulled the church back onto its foundation with construction vehicles chained to the structure. Crews put steal beams under the structure with lvory soap between them so the church would slide back into position.

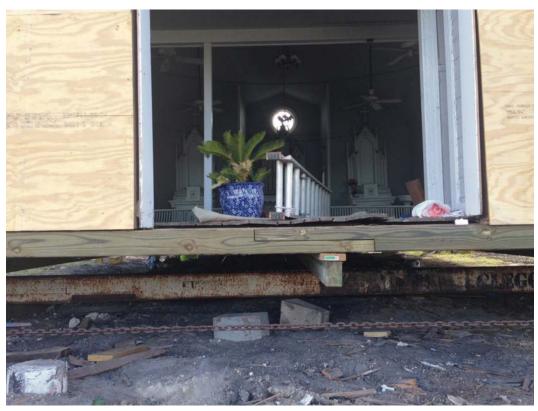
The Clegg Services crew lifted the church inch by inch with pump jacks and air bags until it was about 4 feet off the ground to do structural repairs underneath.

About two weeks ago crews slowly lifted the structure inch by inch with pump jacks and air bags. When the church was about 4 feet off the ground, the crews started doing enough structural repairs so the church could be moved. The floors and walls were reinforced.

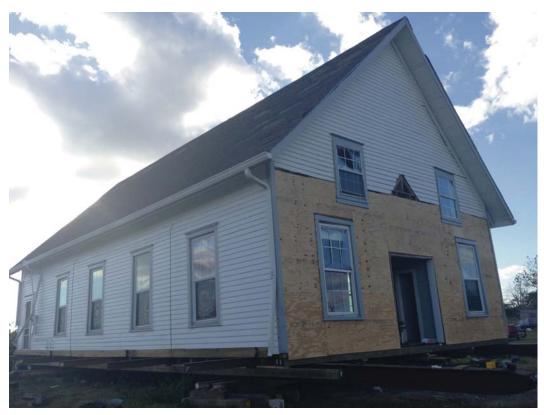
Clegg Services pulled the iconic McFaddin Church back onto its foundation. Hurricane Harvey blew the church about 15 feet of its foundation and caused the structure to lean at about a 30 degree angle.

Monday, crews with Clegg Services and Galveston-based McMillan Building Movers pulled the church back onto its foundation with construction vehicles chained to the structure. Crews put steal beams under the structure with Ivory soap between them so the church would slide back into position.

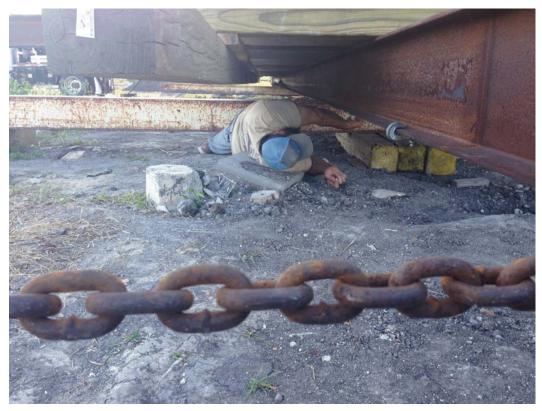
Gilbert Rodriguez with Clegg Services puts ivory soap on metal beams underneath the McFaddin church. Crews used the soap to help the church slide back onto its foundation.
